Failure Analysis at Stem Valve Fire Hydrant in LNG Plant

Juli Mrihardjono, Herman Abidin Pohan*, Seno Darmanto

Mechanical Engineering, Vocational School, Diponegoro University, Semarang, Indonesia
Jl. Prof. Soedarto, SH. UNDIP, Tembalang, Semarang, 50275, Indonesia

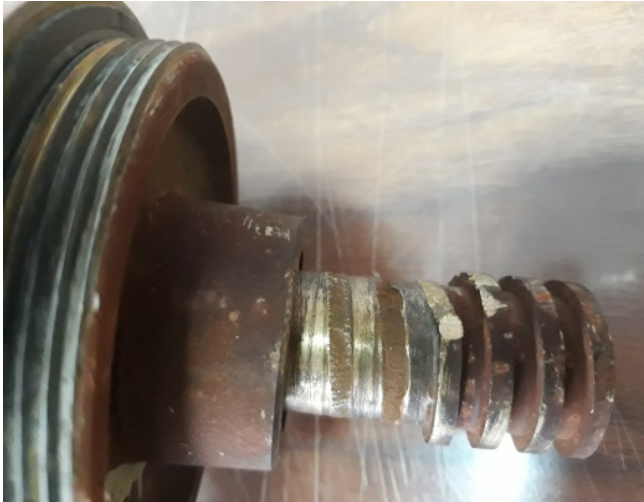
Figure 2. Stem valve that experience a fracture condition

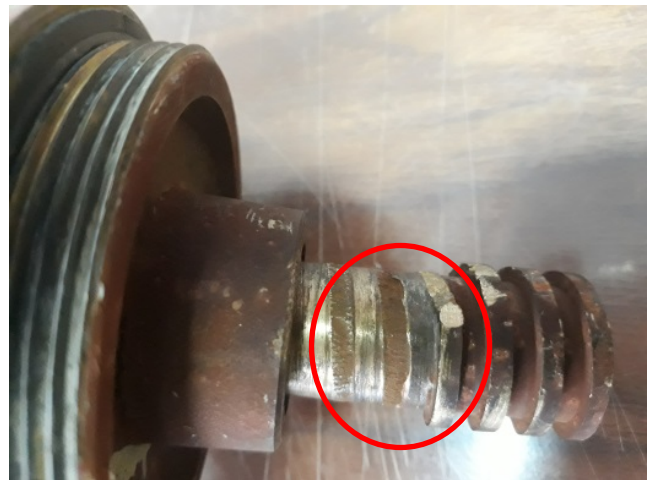
Figure 5. Fracture at Thread of Stem Valve

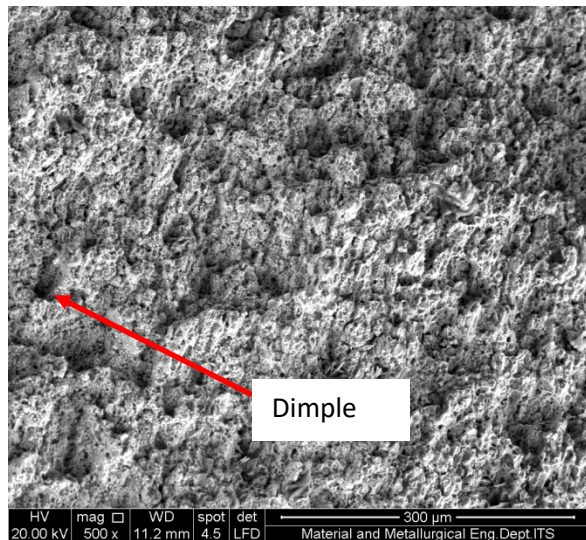
Figure 7. Dimples on the Face of Fracture

Although it is not specific to measure grain size changes, it can be ascertained that there is a change in grain size, it is known from the results of SEM (Scanning electron Microscopy) testing that there are Microvoids or Dimples which indicate that Shear Over Stress results in changes in grain size.

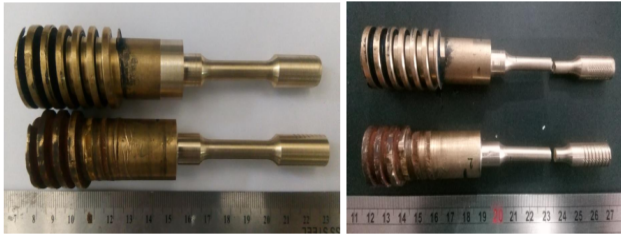
Figure 8. Tensile Test at Stem Valve

From the data, it can be seen that there is difference between the stem valve which has been broken with the new stem valve, this show that there has been decrease in tensile strenght at the material [4].

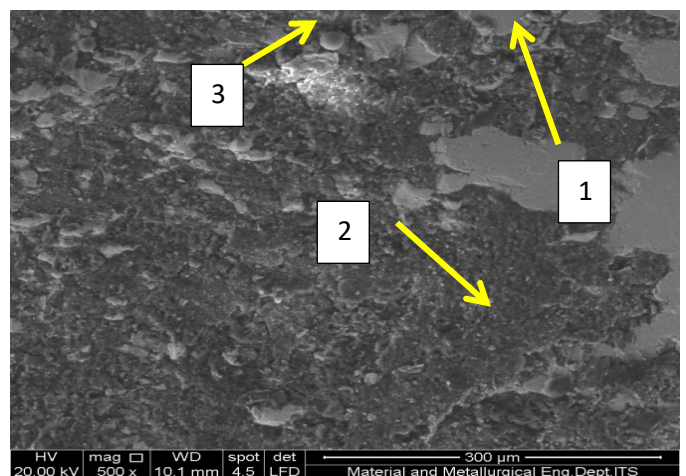
Figure 11. Special sign for stress corrosion cracking

1. The intergranular path of the basic fault shown, appears to be an irregular fracture display
2. Multiple secondary intergranular cracking
3. Corrosion products that appear on the surface

From the characteristics contained in the SEM test results it can be said that Stress Corrosion Cracking occurs in the Stem Valve Fire Hydrant material.

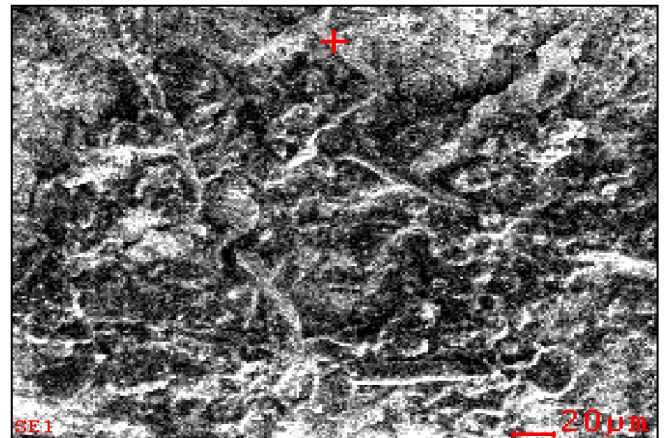
At the sampling point at the other fault location it was also read that there was a high enough carbon content, in many literature it was also mentioned that one of the most found Impurities caused by Corrosion Cracking was carbon and sulfur content following SEM and EDX data at the other fault location:

Figure 12. SEM test result at another location

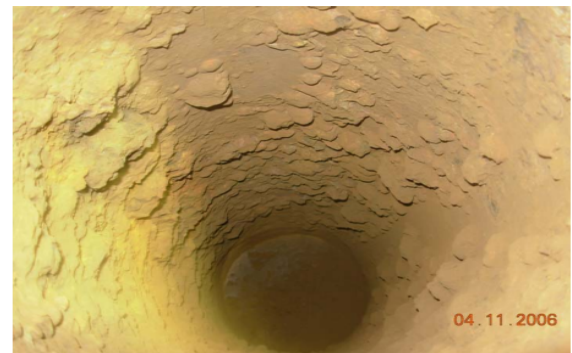
From the EDX test data, it was found that the oxygen content in the Crack area is quite high, where oxygen is one of the elements that can cause Corrothion in Copper Alloy Materials, besides that there is also Fe content on the Crack surface which is one of the elements that can cause corrosion . And from all the elements detected there is a fairly high carbon element thought to originate from erosion in the internal Fire Water pipe, the carbon element was one of the biggest contributors as Impurities [3].

Figure 13. Internal surface condition of fire pipe
