Failure Analysis Of Water Pump Shaft

Abstract- A water pump shaft for utility water raw material was failed. The shaft was broken into two parts. While in dismantling, the sand was found in chamber between bearing and shaft. There was also a bolt in the impeller. According to reports, the pump has been repaired and since there was no replacement shaft but the shaft was reused in reverse position. There was no inspection of the shaft when it was disconnected by operational reasons. The failure analysis of the broken-shaft was performed to investigate the cause of the failure. Two inspection and analysis were performed those are visual inspection and material identification and analysis. When material analysis of the shaft was carried out there was difference between examination and data specification of the shaft. The material identification indicate that the material was AISI SS 304 whereas specification data states SS 316. Both materials have similar tensile stress, so the difference was not the contributor of the failure. The present of foreign material was consider as the cause of the failure. The foreign material caused to stuck on rotation of shaft and increasing in tensile o

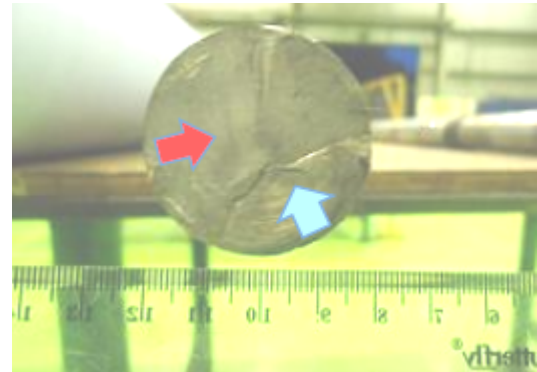
Visual inspection was carried out to analyze the modes of failure. One of the picture can be seen at Fig.2. This leading to hypotheses that shaft failed in torsion loading condition.The figure shows that there is a crack initiation. This mode of failure was consider that shaft sustained a rotational load that cause the tensile stress over its ultimate strength. This initial crack was mis-inspection. From historical maintenance data, the shaft was not checked for it.

Figure 2 also shows that the fracture plane was perpendicular to the longitudinal plane of the shaft. It was indicated that crack propagation occurred under induced flexural fatigue loading.

Figure 2. Modes of failure: a. initial crack portion (lower arrow), and b. failure portion (upper arrow)

Figure 2 shows that there also was a fatigue zone. The fatigue zone can be described as follows: a smooth rubbed, and velvety appearance, the presence of waves known as "clam-shells" or "oyster-shells", "stop marks" and "beach marks," and the herringbone pattern or granular trace which shows the origin of the crack, as seen at Fig3 [6]. In general, stop marks indicate the variations in the rate of crack propagation due to variations in stress amplitude in a cyclic application varying with time.

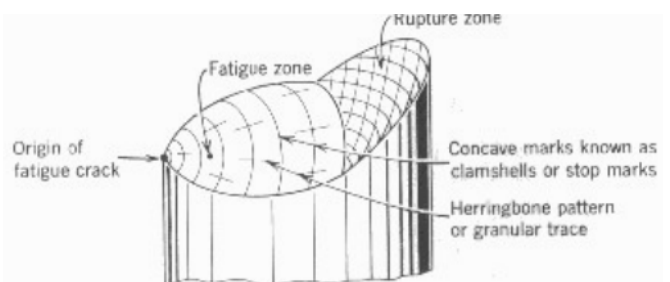
There are three portion area of the failure, portion that large plastic deformation occurs (large portion), portion of brittle fracture, and portion of rotational bending fatigue charactaeristic.A large portion of the failure surface was flattened and smeared off. This surface condition was considered due to a repeated grinding agains the fracture surface with mating part while the motor runs after complete fracture. The fatigue occurs because of pump operation over 40000 hours without preventive maintenance.

Figure 3. Failure zone

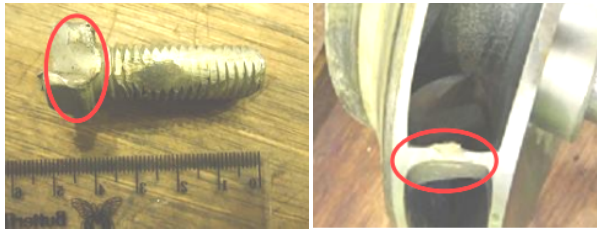
The cause of the over tensile strength was of the foreign material, those are sand and bolt in pump chamber. The bolt that found in the chamber and damage of impeller can be seen at Fig.4. The rotation of shaft was stucked by the bolt, cause tensile stress increased in the shaft over its tensile strength. The initial crack extents until shaft

broken.Besides the stucked, imbalance that cause of bolt exerted in impeller could also be contributor of shaft failure. It can also be seen that their direction of initial crack and failure was different. This is caused by maintenance activity that change the vertical position of the shaft This failure phenomena is similar to that in pump shaft failure studied by some researcher [2, 3, 4, 5].

Figure 4. Bolt in pump chamber and damage of impeller

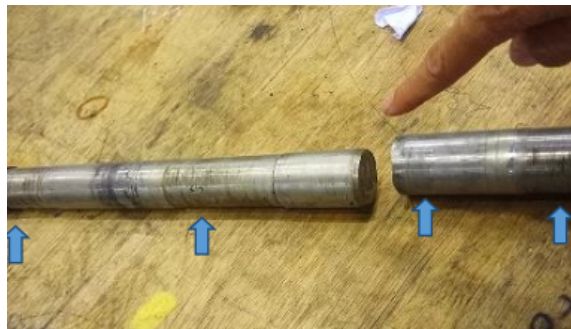
Another cause of failure was worn out of shaft at bearing location, that can be seen at Fig. 4. This wear cause the shaft cross section area reduced and lack to withstand tensile stress. The stress is a high stress level of induce fluctuating stresses that exerts from a start and stop cycle mode of operation. The shaft experiences cyclic flexural load and torsional load during pumping operation. At this location, an excessive plastic deformation could be induced and severe localized stress occurs. This would lead to fatigue crack. The mass of shaft is an factor that induce cyclic flexural stress. This stress is distributed uniformly along the length of the shaft between the bearing supports. At the bearing support, reduced cross section area induces a local stress gradient then this stress could be the contributor to failure of the shaft. The fillet corner was too sharp to withstand the stress concentration for longer duration.

Figure 4. Shaft cross section area reduction caused by wearing out of bearing bushing
