Reliability Analysis of Fire Water Line

Abstract- The purpose of this research is to analyze the reliability of fire water as water distribution for emergency condition. To determine the remaining useful life (RUL) of fire water line, this research will apply counting process so that the rate of remaining useful life (RUL) of fire water line can be known. The data used as basis for calculation is failure data gained from technical division databases from 2018. The data obtained will be processed using visual inspection and ultrasonic thickness test method to produce remaining useful life of fire water line. From 5 example fire water line, only 3 needed replace of fire water line cause less than 10 year. RUL to 9 year at 10" and 12" Train C/D, 2.45 year at 14" Train C/D, 8 year at 10" and 12" Utilities I. The mathematical modeling will be verified using visual thickness and ultrasonic Test method to ensure Remaining useful life of fire water line at Badak LNG. Visual inspection refer to API 571 and ultrasonic test refer to API 570 and ASME B31.3

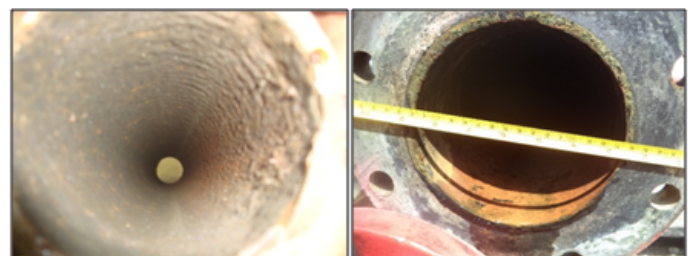
Figure 1. Internal Pipe Condition 3" and 6"

As shown from Figure 1, internal pipes are still in a good condition. General corrosion occurred on the pipe internal surface slightly. A very thin scale layer was found along the surface area. There was no deposit found that could reduce flow rate of fire water.

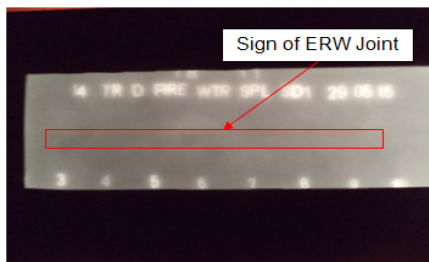
Figure 2. Radiographic Examination of 14" Train C/D

In addition, during inspection of 14" of fire water pipe of Train C/D, it was found that this pipe was constructed by using ERW type pipe. Additional test, Radiographic Examination, was also conducted to ensure that this pipe is ERW (electric resistance welding) type. This finding confirmed the information that during the construction of Train A/B/C/D, specification of fire water pipe with size of 14" up to 24" are SCH 10 API 5L-B ERW. While the current PTB spec is PIPE BE STD CS API 5L-B SAW [5]. Refers to ASME B31.3, ERW pipe has less welding joint efficiency than SAW [6]. Therefore, as also on memorandum 405/BM33/2009-334, ERW pipe potentially lead to pipe burst with combination to internal corrosion. Since 14" fire water pipe of Train C/D is heading toward KOD Plant-21, it is strongly recommended to replace the pipe by using current specification pipe.
