Reliability Analysis of Fire Water Line

Abstract- The purpose of this research is to analyze the reliability of fire water as water distribution for emergency condition. To determine the remaining useful life (RUL) of fire water line, this research will apply counting process so that the rate of remaining useful life (RUL) of fire water line can be known. The data used as basis for calculation is failure data gained from technical division databases from 2018. The data obtained will be processed using visual inspection and ultrasonic thickness test method to produce remaining useful life of fire water line. From 5 example fire water line, only 3 needed replace of fire water line cause less than 10 year. RUL to 9 year at 10" and 12" Train C/D, 2.45 year at 14" Train C/D, 8 year at 10" and 12" Utilities I. The mathematical modeling will be verified using visual thickness and ultrasonic Test method to ensure Remaining useful life of fire water line at Badak LNG. Visual inspection refer to API 571 and ultrasonic test refer to API 570 and ASME B31.3

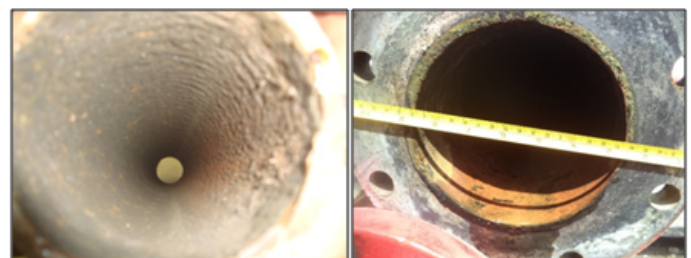
Figure 1. Internal Pipe Condition 3" and 6"

As shown from Figure 1, internal pipes are still in a good condition. General corrosion occurred on the pipe internal surface slightly. A very thin scale layer was found along the surface area. There was no deposit found that could reduce flow rate of fire water.

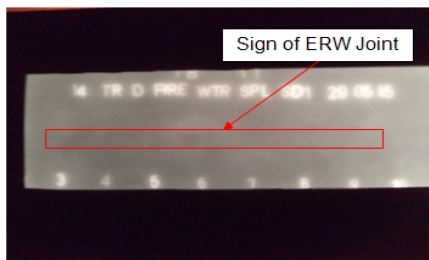
Figure 2. Radiographic Examination of 14" Train C/D

In addition, during inspection of 14" of fire water pipe of Train C/D, it was found that this pipe was constructed by using ERW type pipe. Additional test, Radiographic Examination, was also conducted to ensure that this pipe is ERW (electric resistance welding) type. This finding confirmed the information that during the construction of Train A/B/C/D, specification of fire water pipe with size of 14" up to 24" are SCH 10 API 5L-B ERW. While the current PTB spec is PIPE BE STD CS API 5L-B SAW [5]. Refers to ASME B31.3, ERW pipe has less welding joint efficiency than SAW [6]. Therefore, as also on memorandum 405/BM33/2009-334, ERW pipe potentially lead to pipe burst with combination to internal corrosion. Since 14" fire water pipe of Train C/D is heading toward KOD Plant-21, it is strongly recommended to replace the pipe by using current specification pipe.

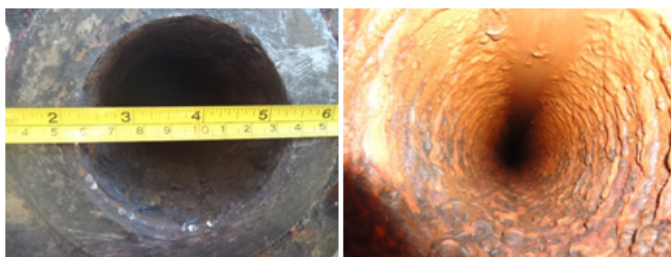
Figure 3. Internal Pipe Condition 3" and 6"

As shown by Figure 3, internal pipes are still in a good condition. General corrosion occurred on the pipe internal surface [7]. On 3" pipe, a very thin scale layer was found along the surface area. There was no deposit found that could reduce flow rate of fire water. While, on 6" pipe, it was found scale and deposit with 5 mm thickness, which is considered acceptable.

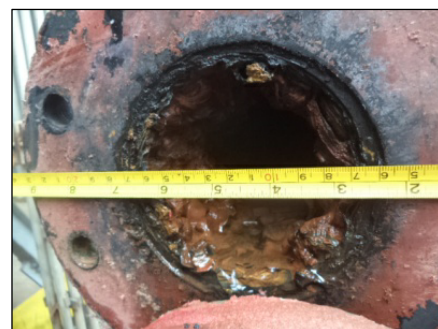
Figure 4. 4" Pipe Internal Condition

As shown by Figure 4, internal pipe of 4" pipe was badly corroded. It was found scale, which is corrosion product of steel, and also deposit. Thickness of scale and deposit that were found is 1.5 cm. Water stagnant inside the pipe is suspected to be the root cause. Scale and deposit lead to pipe diameter reduction (30% of initial diameter). Assuming that pressure of fire water system is maintained constant, this condition will lead to flow rate (Q) reduction up to 50%. In case of fire, the piping system will not able to supply 10 liters/min.m² of water for major equipment as required on PTB General Specification. By the result of 4" pipe internal assessment, it is recommended to replace all 2" – 4" pipes at Utilities II.
