# Historic Sites during the World War II in South Konawe, Southeast Sulawesi as a Source of Historiography

### **Excavation of Japanese Military Extensive Administration and Maintenance Area at Kendari II Airfield, South Konawe**

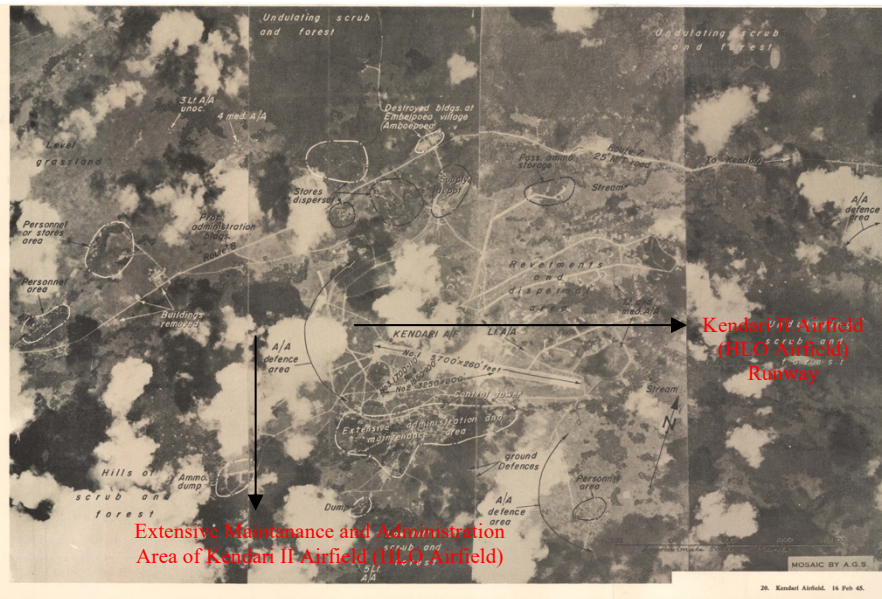
Figure 1. Situation Map of HLO Airfield Area on 16 February 1945  
Source: Collection of *Allied Geographical Section*.

The aerial photographs taken on 16 February 1945 show that during the World War II, Kendari II Airfield (HLO Airfield) had four runway lanes (1 main runway, 3 aircraft taxi lanes). Around the runway, there were a number of defensive buildings in the form of bunkers, earthen forts, ammunition storage warehouses, and several

defensive posts equipped with anti-aircraft weapons. In the south of the runway, there was a concentration of buildings annotated as extensive administration and maintenance area (see Figure 1). The completeness of the existing physical buildings shows that during the World War II, Kendari II Airfield area was an important operational area for the Imperial Japanese Army (*Allied Geographical Section, 1945*).

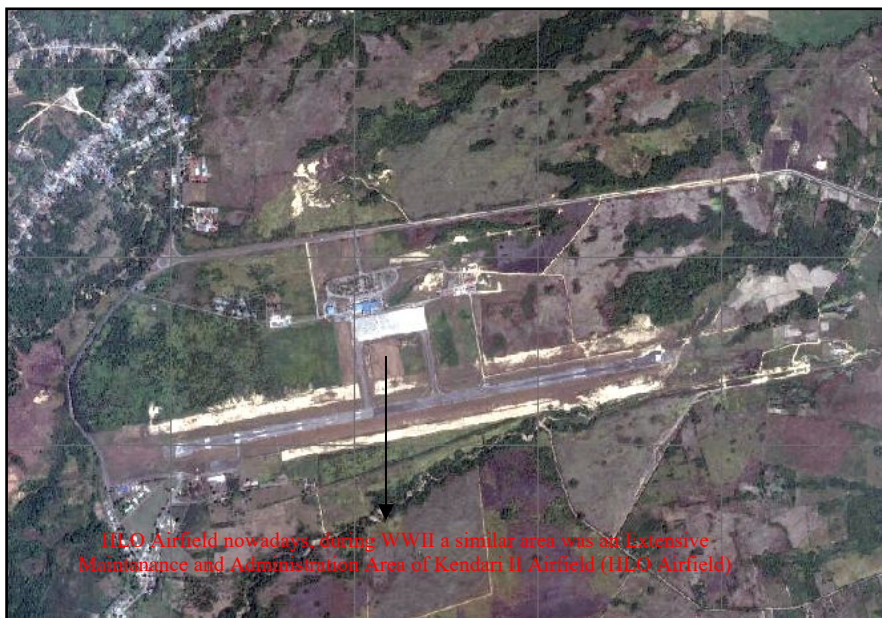
Figure 2. Situation Map of HLO Airfield Area Nowadays  
Source: *Google Earth, 2016*.

Nowadays, some of the physical buildings operated at Kendari II Airfield (HLO Airfield) area have undergone changes, but most of them are still deposited underground. The runway of  $\pm 2600$  m of concrete and asphalt is the main attribute in

supporting the flight operations. The runway stretches from the west to the east. The average altitude of Kendari II Airfield area is 44 meters above sea level, with the lowest point is 18 meters above sea level in the east and the highest point in the west is 42 meters above sea level. Thus, it can be seen that *Kendari II Airfield* (HLO Airfield) area is a relatively plain area and ideal for the location of the establishment of an airfield (see Figure 2). The interesting thing on the south side of the runway is that there is a river on the left and right sides of which a number of remains of defensive structures and buildings are found.

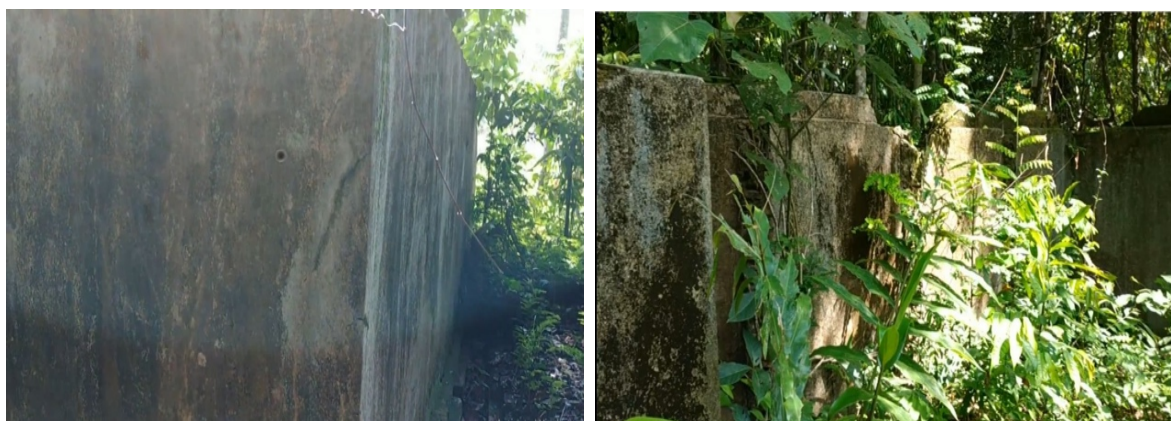
Figure 3. Administration and maintenance Area at Kendari II Airfield (HLO Airfield) Area

After conducting a toponym deepening based on the results of research that had been conducted since 2015 – 2016, it is known that the area with the most massive remains is the Japanese military extensive administration and maintenance area at Kendari II Airfield (HLO Airfield). The findings of the surface and the building remains provide an illustration that the area was once the center of the Japanese Government military operations during the World War II (see Figure 3).

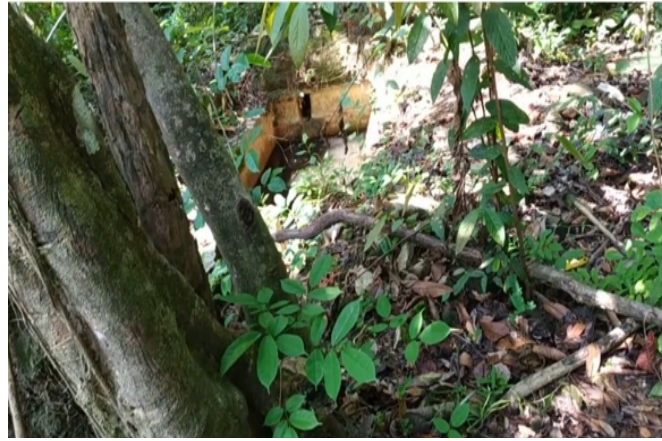
Figure 5. WWII Remains at A3 Area, Kendari II Airfield (HLO Airfield) Area  
Source: Excavation Team of Department of Archeology of Universitas Halu Oleo, 2017-2019.

A3 Area is located in the central area of the Japanese military extensive administration and maintenance area. The findings of the surface in this area are pictures of sanitation and hygiene buildings used during the WWII by the Japanese military (see Figure 5). The purpose of opening the excavation box at the first location was to reveal details of the sanitation system used in the Japanese military extensive administration and maintenance area during the WWII.

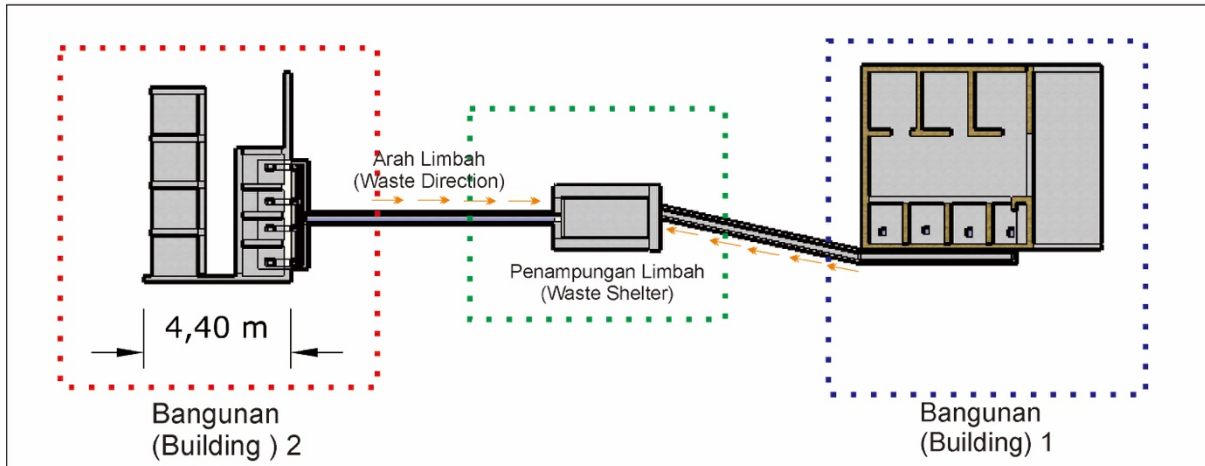
Figure 6. Building Reconstruction at A3 Area, Kendari II Airfield Area,  
Source: Excavation Team of Department of Archeology of Universitas Halu Oleo,  
2017-2019.

A3 Area is in the form of 2 main buildings in the middle of which there is a waste storage pit. The first building is located in the east in the form of a sanitation cubicle. The building in the east still has an intact perimeter wall. The sanitation building in the east has a length of 5.10 meters and a width of 5.58 meters. The sanitary building has 3 chambers in the south and 3 chambers in the north. The 3 chambers in the south are the waste disposal chambers, while the 3 chambers in the north are the body cleansing chambers. Each chamber in the south has a size of 1.05 meters x 1.20 meters. On the other hand, each chamber in the north has a size of 1.4 meters x 2.06 meters. The sanitation buildings in the east and the waste storage area are connected by a 20 cm waste disposal area.

Moreover, at this location there is also a similar building for sanitation in the west of the waste storage pit. The building in the west of the waste storage area is sanitation and hygiene building in the form of chamber as found in the building in the east. The building in the west is rectangular with a size of 6.25 meters x 4.40 meters. The remains of the building can still be seen to have 4 chambers facing each other with the middle part between the chambers is an open space. The four chambers facing each other have different functions when viewed from their morphological conditions. The first line chambers are for body hygiene activities. The size of the chambers is uniform, by 1.4 meters x 1.2 meters. On the other hand, the second line chambers are in the form of a waste disposal chamber (WC). This is clearly evidenced by the presence of a toilet in each chamber. The size of the second chamber is smaller than the first, by 1.25 meters x 0.85 meters. Similar to the sanitation building in the east, the sanitation building in the west also has a sewer that leads to a waste storage facility with a length of 7.40 meters and a width of 20 cm.

Meanwhile, the waste storage area, located between the two sanitation and hygiene buildings, is rectangular with a size of 3.2 meters x 1.9 meters. The building has a depth of 2 meters with the bottom of the shelter in the form of soil. One of the most striking morphologies is the existence of pits in the building walls that lead to the river that runs along this area. The existence of the pits is allegedly a mechanism

to cope with the flow of water entering the reservoir so that the storage room will not experience problems if the incoming water discharge is too much. Additionally, the bottom of the shelter in the form of soil is intended as an effort to absorb waste naturally into the soil. The complete reconstruction of the A3 Area can be seen from the top view plan below:

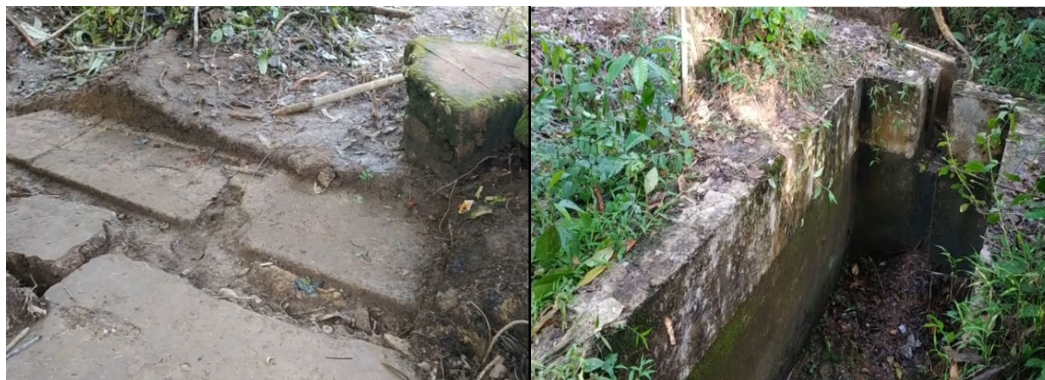
Figure 10. Floor Remains and Waste Storage at A1 Area, Kendari II Airfield (HLO Airfield) Area  
Source: Excavation Team of Department of Archeology of Universitas Halu Oleo, 2017-2019.

A1 Area is in the form of a floor structure in which one of its parts is in the form of a chamber. At the third area, the findings of surface show that during the WWII this area was a very wide hall. The area of the structure at the third area is 30 meters x 6 meters. In the chamber area, the width of the building structure reaches 6 meters while in the lobby of the other room it reaches 3 meters. Subsequently, the building remains at A1 Area have a part in the form of a waste storage room (see Figure 8).

The excavation results show that this building is a building that is mutually sustainable and whole. The building is divided into two main rooms. The first room is spacious hall corridor with a size of 25 meters x 3.5 meters while the second room is a room with a much smaller area, by 5 meters x 6 meters. In this second room, there are 4 waste disposal chambers. All of the chambers is 1.2 meters x 0.8 meters. The chambers have one channel leading to the storage channel which is at the back of this building unit. One thing that distinguishes this building from the buildings in the second area is the floor formation which is in the form of rectangular cement molds arranged like tiles. Meanwhile, the floor formation of the barrack building in the second area is only in the form of cement cast made evenly on the entire building floor. Furthermore, the characters of the walls of the remaining buildings in the third area are similar to the other remaining buildings in the WWII Japanese military administration and maintenance area. It consists of half part in the form of 1-meter-high cement wall while the upper part is a combination of wooden walls or without walls.
