Technology CT Scan 128 Slices in Emergency Pneumotorax and Pneumomediastinum Cases

Lilik Lestari^{1*}, Muhammad Harris Sis Sultansyah²

ABSTRACT. Pneumothorax and pneumomediastinum are complications of mechanical ventilation of the pleural and mediastina cavities. This study aims to report the findings of a 128-slice 3D chest scan with an axial coronal view for a case of pneumothorax and pneumomediastinum. Research conducted at dr. Ario Wirawan, Salatiga. The study used a CT scan 128-slice type Ingenuity CT 120 kV, series 502 idose 4, slice thickness 0.64 mm, zoom 1.0 and used contrast. The CT scan imaging results were qualitatively analyzed by experts. The results showed four cases with pneumothorax and pneumomediastinum, and only pneumothorax was found in seven cases.

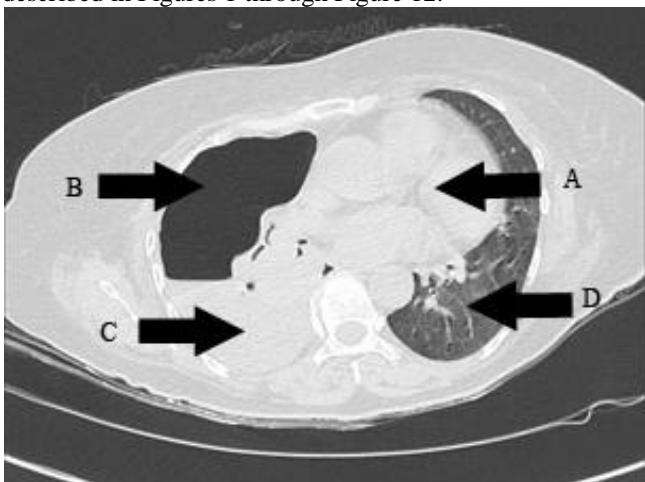
Fig.1. The results of a thoracic CT scan, it is known that the cardiac shape and size appear normal (A), there is a right pneumothorax (B), a mass in the lung dextra (C), left lung known normal shape and size.

The CT scan results in these cases could be categorized into two criteria, namely *first* were only pneumonia cases found, and *second* pneumonia with mediastinal (pneumomediastinum) cases was found in one patient. First category as shown in Figure 1, the results of the CT scan explain that there is a pneumothorax in the right lung caused by a mass in the right lung, which is recurring. Figure 2, Figure 3, Figure 4, Figure 5, Figure 9, Figure 10, and Figure 11 show a lung mass with a right pneumothorax. In the right lung, it is known that a pneumothorax is almost of the right lung field. As stated by Nagarsheth and Kurek, a chest CT

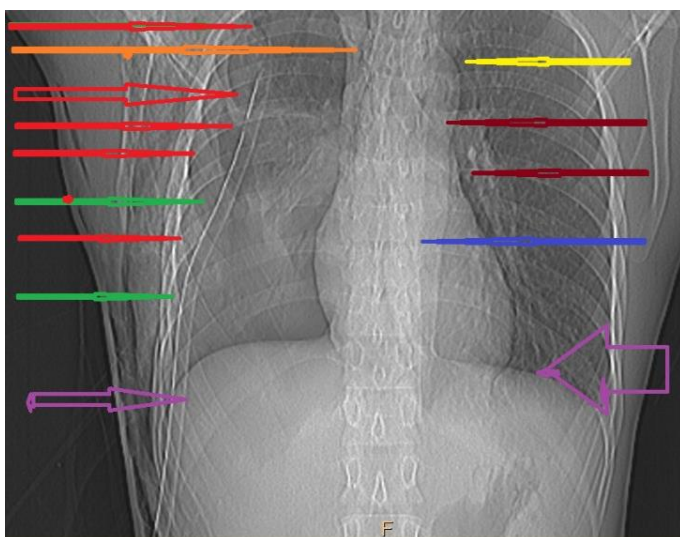
Fig. 8. Scannogram CT scan technology 128 slices, it is known that there is a Water sealed drainage (WSD) tube that is installed in the lung dextra. The end of the tube is at the level of the intercostals 2-3 dextra. In the picture, you can find a WSD tube that was installed to treat a pneumothorax

dextra (red arrow). Pneumothorax dextra (green arrow), pneumomediastinum (orange arrow), and thoracic aortic arch (yellow arrow).

Pneumomediastinum occurs when there is air or gas in the mediastinum [16]. The most common cause of pneumomediastinum is the spontaneous rupture of the alveoli in the lung, which allows air to leak into the mediastinum [7]. In Figure 6, Figure 7, Figure 8, and Figure 11, CT scan can describes an axial pneumomediastinum. According to Zylak et al., digital computed tomographic (CT) radiography can assist in establishing or confirming the diagnosis of pneumomediastinum [17].
