### JURNAL WILAYAH DAN LINGKUNGAN

# Identification of Land Use Changes Due to Changes in Coastlines in the Amurang Coastal Area, South Minahasa Regency

Abstract: Indonesia's coastal areas are dynamic and vulnerable to physical, economic, and socio-cultural changes. This study aims to analyze land use change due to shoreline change in the coastal area of Amurang, South Minahasa Regency, 2005-2022. The main data used included Landsat 7 ETM+, Landsat 8 OLI/TIRS, and Landsat 9 OLI-2/TIRS-2 images, which were processed using GIS-based spatial analysis methods. Shoreline analysis was conducted using the Digital Shoreline Analysis System (DSAS) technique to measure changes in accretion and abrasion. The results showed significant changes in land use. In Kawangkoan Bawah Village, the water body turned into 9.23 hectares of green open space and 11.32 hectares of built-up area, in line with shoreline accretion with an average transect value of 68.11 meters. In contrast, in Lopana Village, green open space turned into 12.24 hectares of water body, corresponding to a dominant abrasion of -126.99 meters. An anomaly occurred in Kawangkoan Bawah Village, where built-up land turned into a water

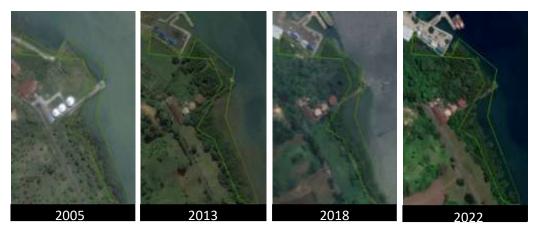
Figure 9. Satellite image of water bodies changed to green open space in Kawangkoan Bawah village

The results of satellite image observation at location 1 show the conformity between the results of spatial analysis with the existing conditions of land use change of water bodies into green open space with the current function is coconut and mangrove plantation land. Location 2, which was surveyed it is a place where the accretion process occurs where waves and part of the river estuary carry sand deposits.

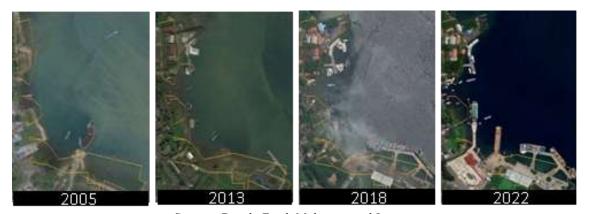
Figure 11. Satellite Image of Water Bodies Changed to Built-Up Area in Kawangkoan Bawah Village

The results of satellite image observation at location point 1 show the conformity between the spatial analysis results with the existing conditions of land use change of water bodies into built-up with the current function is the land of water transport facilities in the form of Amurang Class II Port. At the point of location 2 that was surveyed is a place where the accretion process occurs where there are sand deposits carried by the flow of the river estuary, as shown in the Figure 11 of coastline changes in Rumoong Bawah village in 2013.

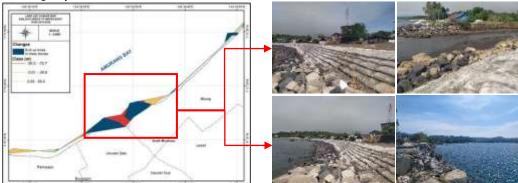
Figure 16. Existing Conditions of Shoreline Change (Abrasion) and Land Use
