Failure Analysis at Stem Valve Fire Hydrant in LNG Plant

Juli Mrihardjono, Herman Abidin Pohan*, Seno Darmanto

Mechanical Engineering, Vocational School, Diponegoro University, Semarang, Indonesia
Jl. Prof. Soedarto, SH. UNDIP, Tembalang, Semarang, 50275, Indonesia

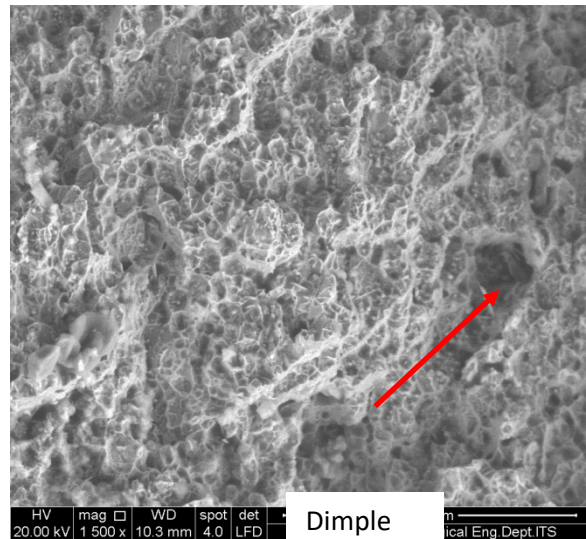
Figure 6. SEM Test

The research was done by Scanning Elecron Mycroscopy at Material Engineering Material Characterization Division ITS Surabaya, observation was conducted in the inner section of the thread, and on the threaded cross section with magnification until 1500 times, so that it can be observed the root cause of the fracture.
