Failure Analysis Of Water Pump Shaft

Abstract- A water pump shaft for utility water raw material was failed. The shaft was broken into two parts. While in dismantling, the sand was found in chamber between bearing and shaft. There was also a bolt in the impeller. According to reports, the pump has been repaired and since there was no replacement shaft but the shaft was reused in reverse position. There was no inspection of the shaft when it was disconnected by operational reasons. The failure analysis of the broken-shaft was performed to investigate the cause of the failure. Two inspection and analysis were performed those are visual inspection and material identification and analysis. When material analysis of the shaft was carried out there was difference between examination and data specification of the shaft. The material identification indicate that the material was AISI SS 304 whereas specification data states SS 316. Both materials have similar tensile stress, so the difference was not the contributor of the failure. The present of foreign material was consider as the cause of the failure. The foreign material caused to stuck on rotation of shaft and increasing in tensile o

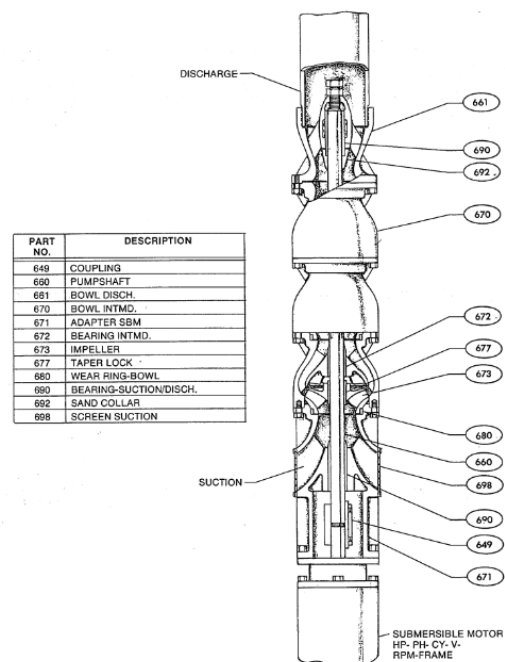
Figure 1. Vertical Centrifugal Pump

The vertical pump used at a typical well was design with stainless steel materials. The construction of the pump and details of pump specification can be seen at Fig. 1 and Table 1, subsequently [1].
